Testing safety valves

Following an incident involving a major steam release after safety valve testing at a UK coal-fired power station, new guidance has been issued. Alan Fitzpatrick explains

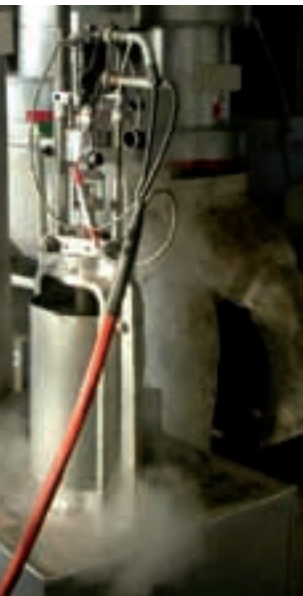
Hydraulic test equipment in place, ready for testing the safety valve

In the 1980s, however, a company called Furmanite developed hydraulic pull and emergency shut test equipment called Trevi test, which enabled safety valves to be tested at 90% of the safe operating limit. It meant a very quick lift, compared to the old live test, and the boiler no longer had to be raised to maximum pressure – with the added

- The safety valve test equipment should be moved as far away as possible from the boiler. One method would be to increase the length of the hydraulic hoses on the testing equipment, typically doubling the existing test length. The calibration gauge may also be replaced by a pressure reading device, to be read remotely

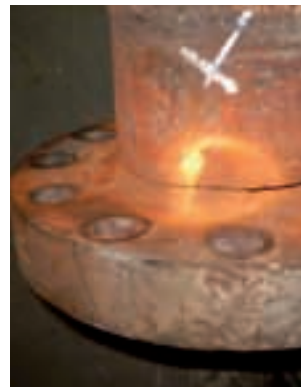
Superheater escape pipe flange for a safety valve, showing typical defect. Under legislation, no inspection is required, since it is part of an open vented line – but no engineer would want to be near, if it failed
